No. 9

Front Coil Spring Orientation

Volvo S40 5/00-12/03 and Volvo V40 5/00-04

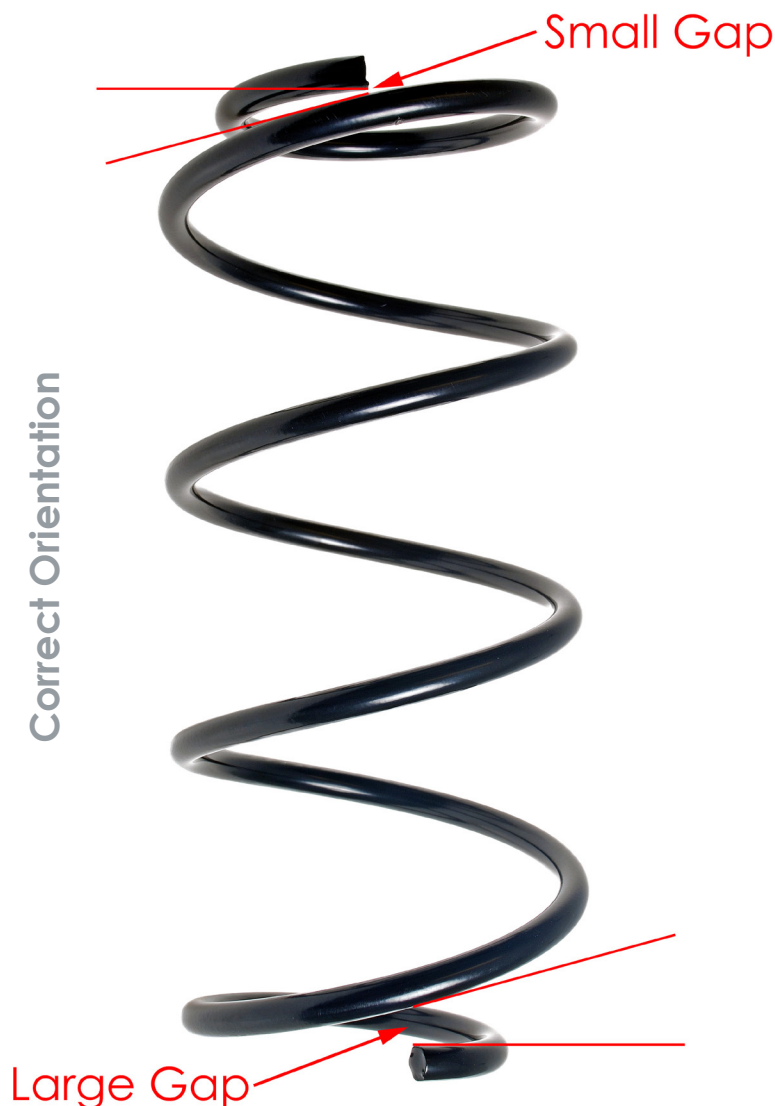
Incorrect installation can cause the spring to bend, or move out of position and rub against the bodywork.

The top end coil also sits slightly flatter than the bottom end coil, giving a better fit in the top bearing.

When replacing front coil springs on the above vehicles, it is important to install them the right way up.

The end with the SMALLER gap (see diagram) should be installed in the TOP bearing.
The end with the LARGER gap should be installed in the BOTTOM spring pan.
